DEAR HAWK OWNERS:

SERVICE BULLETIN 4-20-89 (a), (b), (c)

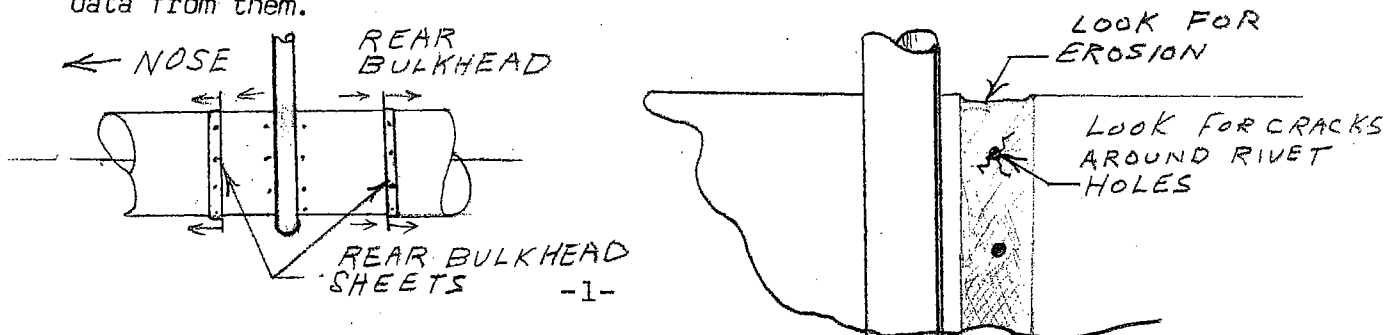
A CGS Hawk single seat, with approximately 400 hrs. total time, was said to have experienced a tail boom failure in flight resulting in a fatal accident. The Hawk was reported to be flying straight and level on a down wind leg at approximately 600 feet when the main boom failed at the rear bulkhead area. CGS has not seen the area of the break, and we are waiting for the boom to be sent to us for inspection and testing. However, we also have reports from that area that the Hawk in question has had numerous hard landings and numerous landing gear leg replacements. We were also told that the area of the failure had a lot of a black sooty residue around it. This would indicate loose rivets around the bulkhead collar.

Black sooty residue indicates loose rivets and parts rubbing against each other. If the bulkhead rivets were loose and allowed the bulkhead to rub against the boom tube due to vibration, it is very possible that this fretting would erode away the bulkhead and/or the boom tube in the area under the bulkhead flange. The amount of rivets used in securing the bulkhead to the tube is not excessive. The normal failure mode is for the boom tube to buckle well before it breaks and flight loads can not load the boom enough to buckle it. We feel the Hawk in question had prior damage before the fatal flight and that improper preflight techniques had been used. Neither the FAA or the NTSB have investigated this accident, so we have no data from them.

Inspect the area of the rear bulkhead for loose rivets or black sooty residue. If either is present, remove the rear bulkhead sheet by drilling out the rivets and slide the bulkhead sheet toward the tail. Inspect the main boom in the area that was under the bulkhead. If any erosion is present, contact CGS Aviation for a fix. If none is found, clean the area with acetone and apply PC-7 epoxy putty around the tube and re-install the bulkhead. Insert the rivets while epoxy is still wet. Wipe off any left over epoxy with acetone. Do the front sheet of the rear bulkhead also. Do not add doublers or sleeves without contacting CGS first. A wrong size doubler can cause more trouble later on.

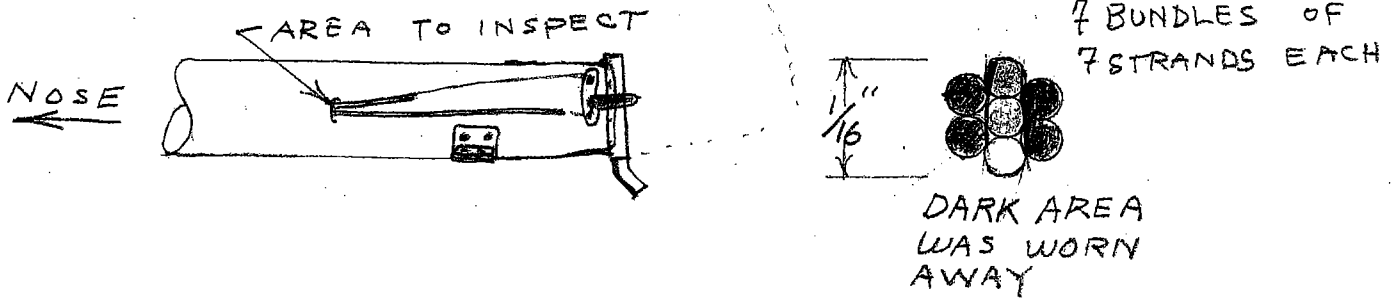
During a demonstration flight at the Sun-N-Fun while in a near verticle bank at approximately 20' altitude and a speed of 60-80 mph, the up elevator cable broke which resulted in an immediate slip to the ground. The right wing hit first, then the nose, which was almost verticle. The plane continued on its back and came to a rest about 75'-100' from the point of impact. The pilot sustained a broken ankle and bruises. The Hawk was a total loss. However, the engine stayed in its place, the seat belt and harness did their job as did the roll cage in protecting the pilot. Many spectators were later heard to comment that had he been flying anything but a Hawk, it would have been a fatality. The pilot, who was conscious the entire time said he thought the up elevator cable broke. Inspection showed the up cable had indeed broken. Further analysis showed the location where the cable broke had been reduced in cross section by approximately 65%. That means only about 2.5 strands were left out of 7. The area of erosion was where the cable and housing exit the main tube near the tail. We had always thought that the stainless cable would saw through the nylon housing. We have recently learned from varied sources that nylon guides, micarta, and other plastics can wear down metals. Further inspection showed that the rudder cables had two frayed strands. The aileron cables showed no signs of wear.

Inspect rudder and elevator cables where they exit the boom tube. You can loosen the clamps and slide the nylon housing forward to examine the cables. It may be necessary to trim off some of the housing. If you see any wear on your cables, replace them and please send the worn portion of your old cable to CGS along with the amount of time in service, and whether it is the up or down elevator or right or left rudder cable.

If any black powder can be seen through the housing or if you have 400-500 hours time on your Hawk, replace cables.

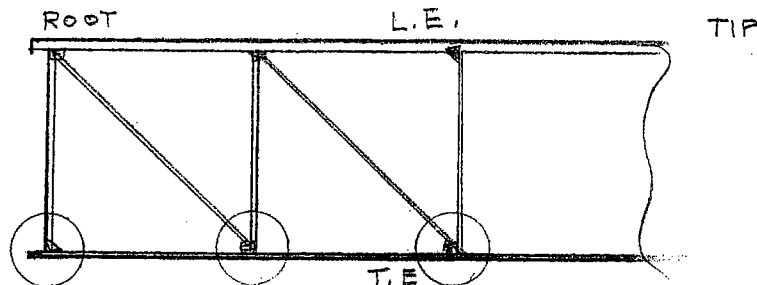
Two customers with 400 and 250 hours and a factory Hawk with 1142 hours had found cracks in wing gussets.

At this time, data is insufficient to determine a cause.

Inspect gussets and if cracked, replace. See Drawing for location of suspect gussets. LET US KNOW IF YOU FIND ANY CRACKED GUSSETS.
